Kerr Lake Vegetation Survey

February 11, 2016

Report submitted by NC State University

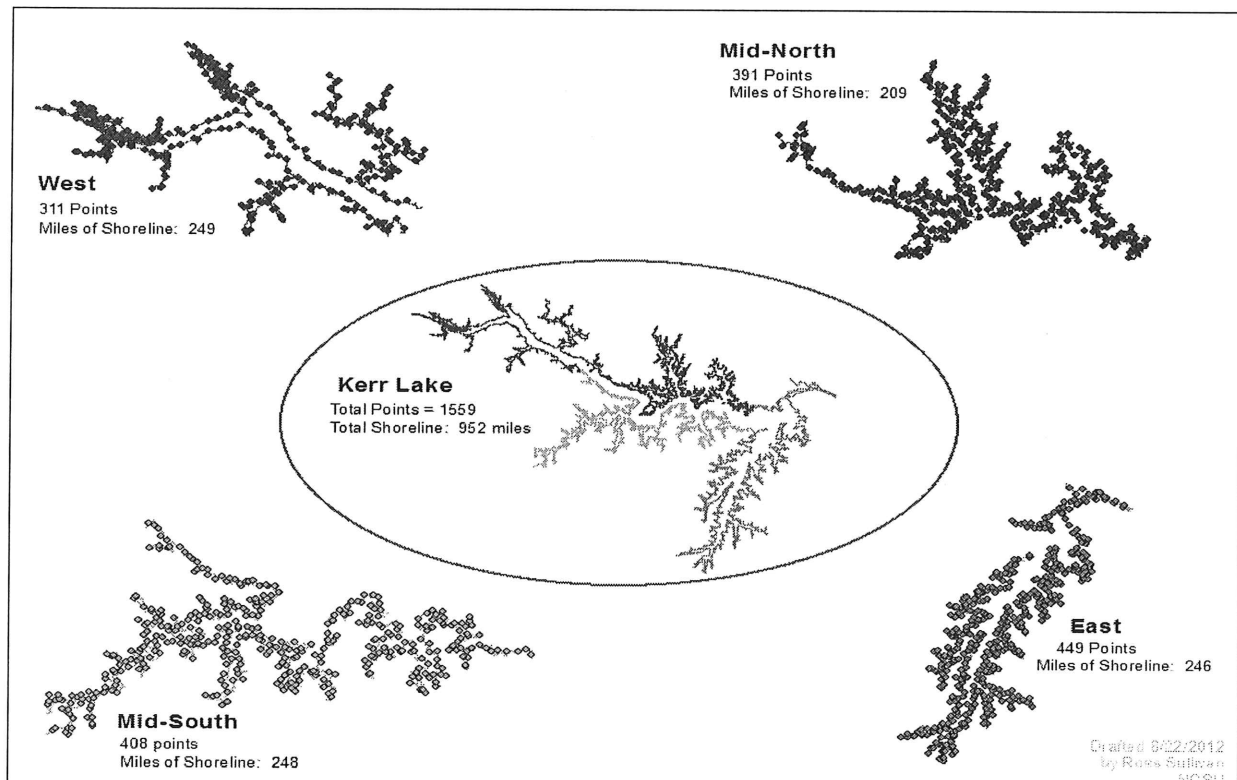
Beginning in 2012, a point intercept method was incorporated in order to more accurately determine species presence/absence and assist in determining Hydrilla spread. A total of 1559 points were placed at an approximately 0.5 mile interval around the shoreline based on USACE shoreline shape file. Some of these points occurred in areas that were not accessible for various reasons including low water, behind culverts, below dam structure. Of the predetermined points, 1307 were actually sampled for vegetation in 2015 (1245 in 2012, 1316 in 2013, 1336 in 2014). The sample method included visual observation of area and 2 rake tosses at each point (or as close as possible to actual point). In addition, Sonar (same method as 2011) was used in areas where Hydrilla was found, along with hand drawn maps and notes. In addition, rake samples were taken at two points around all boat ramps.

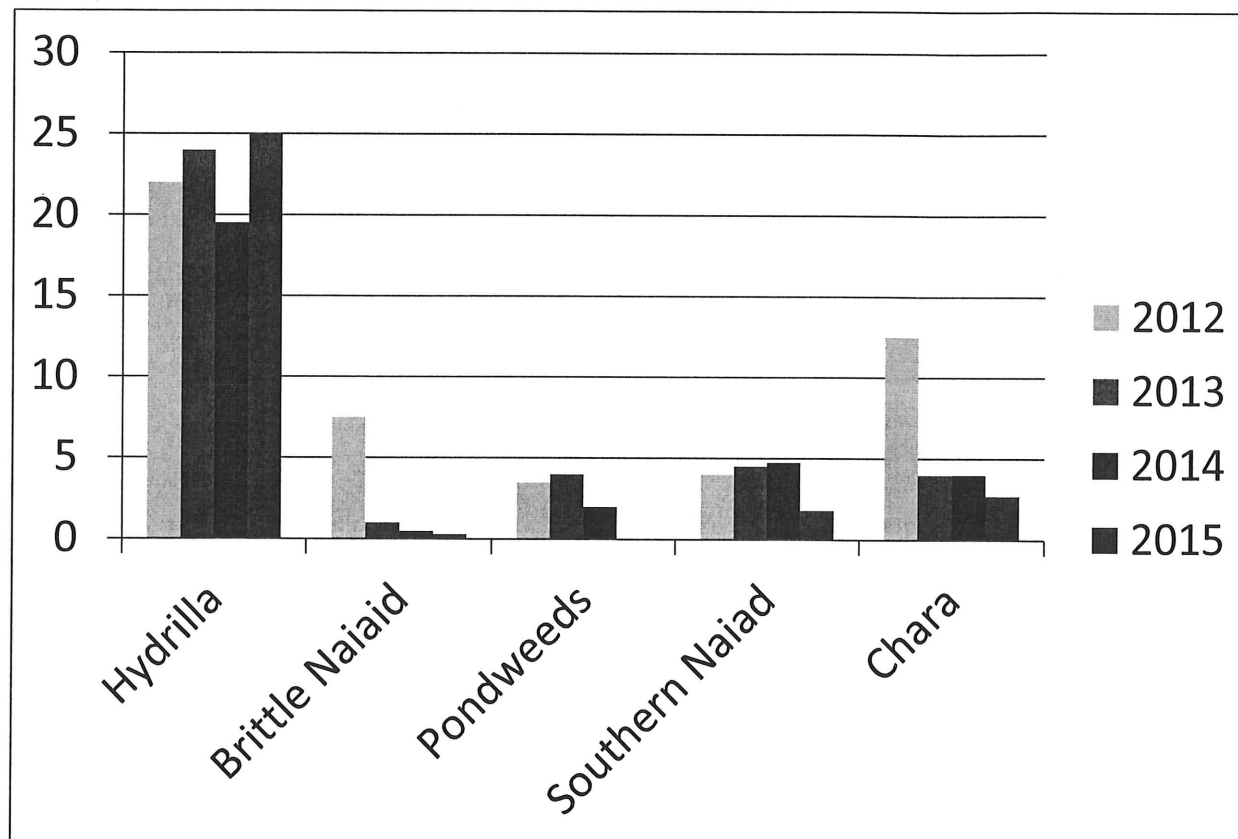
Percent Plant Occurrence by Species
(based on 1245 points in 2012, 1345 points in 2013 and 1336 points in 2014, 1308 in 2015)

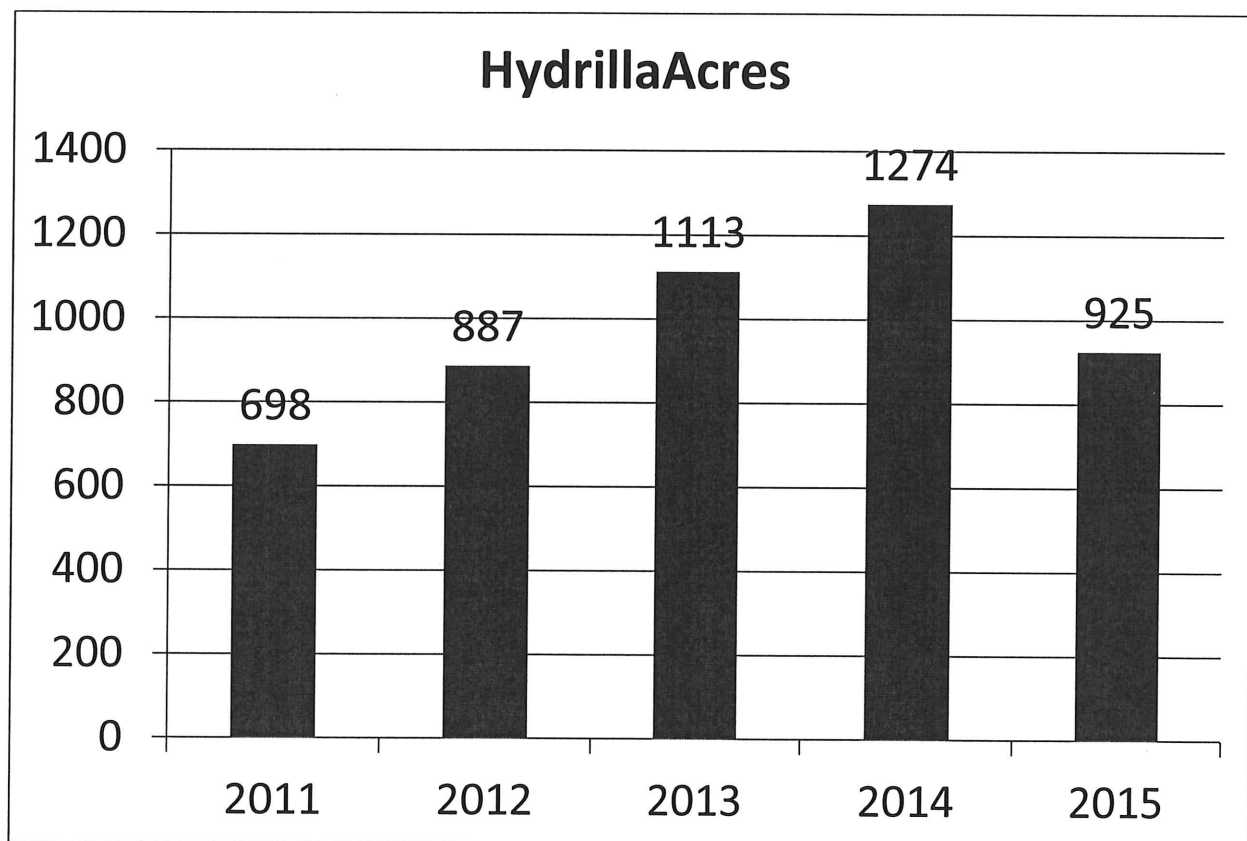
Based on the information obtained during the survey, our estimated total acreage of Hydrilla in Kerr Lake is 925 acres, located mainly in Nutbush Creek and Little Nutbush Creek. Of the 349 acre decrease in 2015, the western part of the lake near the Staunton View area and west of bridges at Clarksville account for most of the difference. Hydrilla populations in this area have been noted in previous years and density will be extremely dependant on water level and flow in future years.

Hydrilla Infestations in 2015:

1. Little Nutbush Creek continues to have the largest continuous areas of shoreline containing Hydrilla; the back of numerous coves had extensive populations as well as many small scattered populations.

2. Nutbush Creek has several large populations of Hydrilla, but also areas with Chara/Nitella and Naiads (esp. *Najas minor*).
3. North Bend Park the site of the original infestations has several small but apparently expanding populations.
